PCB Source Control Investigation of the City of Tukwila Stormwater System

Jorgensen Pipe Discharge Area
City of Tukwila, WA

December 2008
Project No. 40407.011

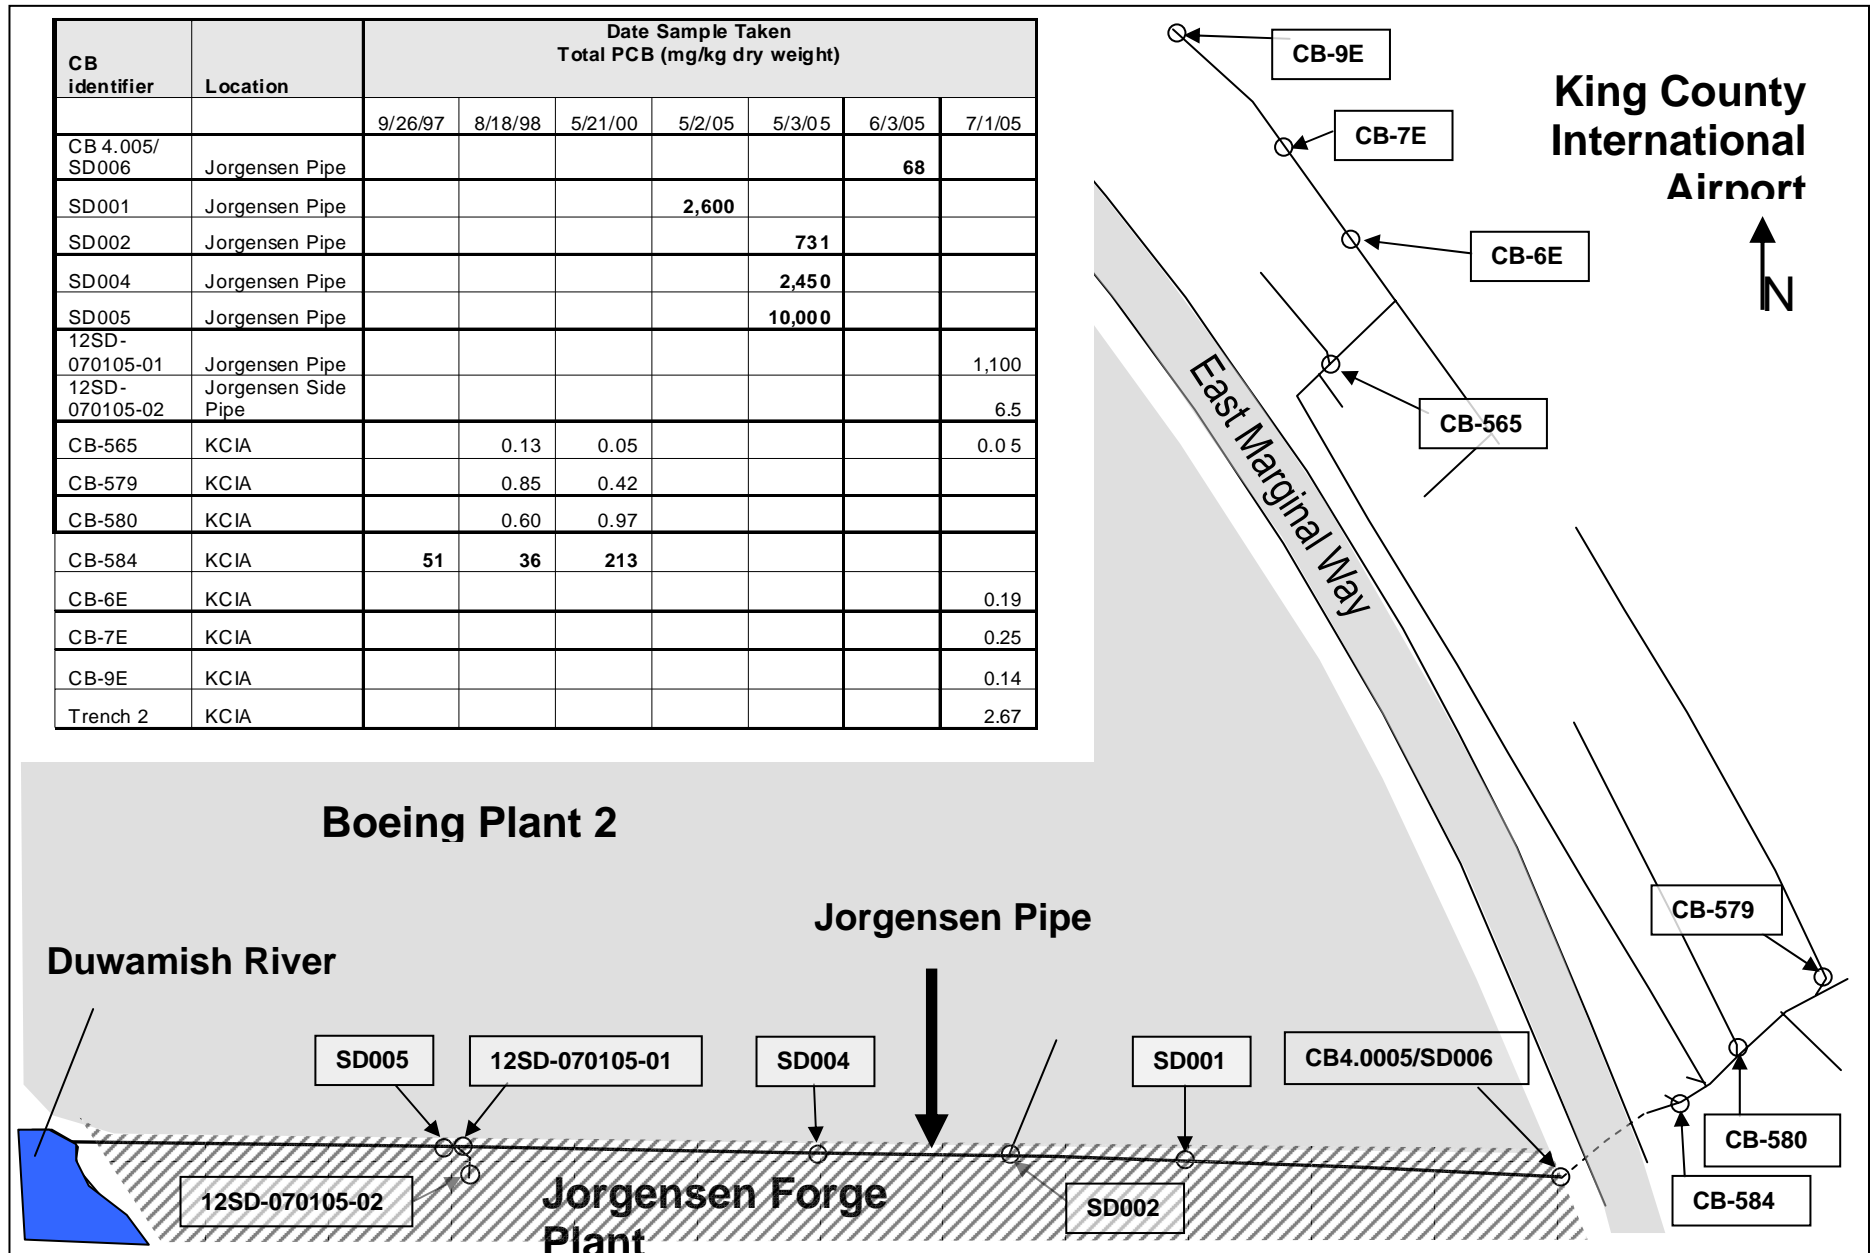
Figure 3: Previous PCB Sampling Locations and Results

Early Action Area 4, the Boeing Plant 2/Jorgensen Forge site, is one of the areas within the LDW that was identified as having particularly high levels of PCBs. Recorded PCB concentrations in surface sediments along this stretch of the River measured as high as 110 mg/kg dry weight(dw). PCB levels above the Washington State Sediment Cleanup Levels were found in sediments at 0-2, 2-4 and 6-8 ft depths near the outfall of the Jorgensen pipe. Studies are still on-going to identify the possible sources of this contamination. A transformer on the Boeing Plant 2 site just north of the Jorgensen Pipe was identified as one likely source of contamination. Grout in the pavement on portions of the Boeing Plant 2 site may have also contributed to the elevated levels in this area. Fill material used at the Jorgensen Forge site is also suspected of PCB contamination. Elevated PCB levels have been found not only in river sediment samples but also in soil and groundwater samples taken in the vicinity of the pipe. However, the highest concentration of PCBs have been found inside the Jorgensen Pipe with levels as high as 10,000 mg/kg dw. Table 1 shows PCB levels that have been recorded over the years in the Jorgensen pipe and in the King County Airport stormwater system that drains to the Jorgensen Pipe.

| CB identifier | Location | Date Sample Taken Total PCB (mg/kg dry weight) | | | | | | |
|---|---|---|---|---|---|---|---|---|
| CB-584* | KCIA | 51 | 36 | 213 | | | | |

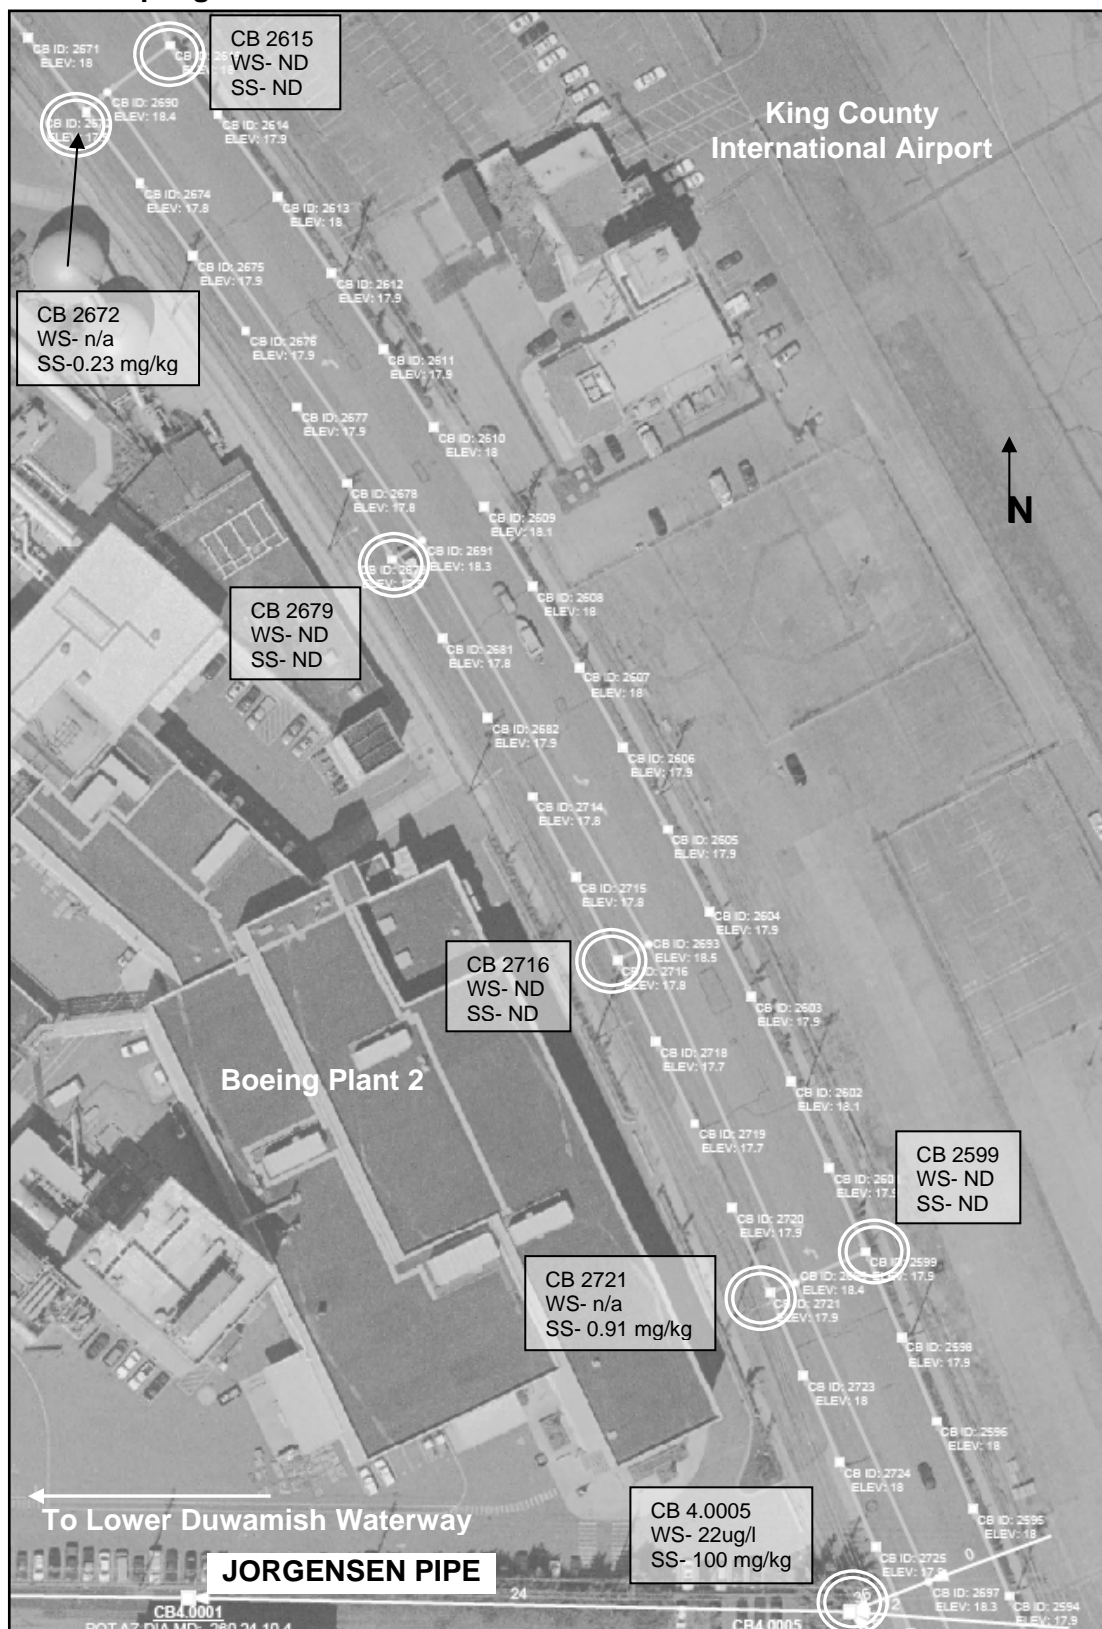
Figure 4. Sampling locations and results

Sediment samples from catchbasins 2679, 2716, 2615, and 2599 were non-detect for PCBs. Detection levels for the analysis were 0.2 mg/kg. Sediment from catchbasin 2672 contained 0.23 mg/kg dry weight PCB concentration. Sediment from catchbasin 2721 contained 0.91 mg/kg dry

weight total PCB concentration. Total PCB levels found in the Jorgensen Pipe CB measured 100 mg/kg dry weight. The Washington State Sediment Quality Standard for PCBs is 12 mg/kg dry weight and the Cleanup Screening Level is 65 mg/kg dry weight. Samples from catchbasins 2672 and 2721 both contain levels of PCB concentration below the Sediment Quality Standard. The sample from the Jorgensen Pipe location had concentrations ten times higher than the Sediment Quality Standard and above the Cleanup Screening Level. All detectable PCBs were Aroclor 1254.

Water samples from catchbasins 2679, 2716, 2615, and 2599 were non-detect for PCBs. Detection limits for this analysis were 0.1 $\mu\text{g/liter}$. No water samples were obtained from catchbasins 2672 and 2721 because water was not present during the sampling period. The only elevated PCB concentrations were found in the water sample collected from the Jorgensen Pipe. The sample from this catchbasin had a PCB concentration of 22 $\mu\text{g/l}$. The acute exposure level is 2.0 $\mu\text{g/l}$. The chronic exposure level in freshwater is 0.014 $\mu\text{g/l}$ and 0.03 $\mu\text{g/l}$ in saltwater. Water collected from the Jorgensen Pipe exceeded both the acute and chronic exposure levels.

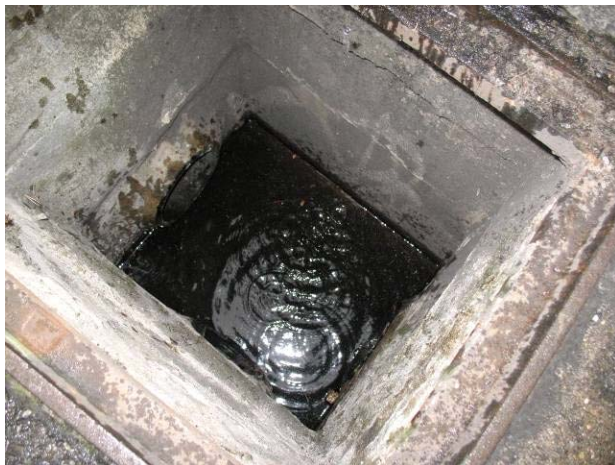
Photo 3. Inside of typical City of Tukwila catch basin in study area

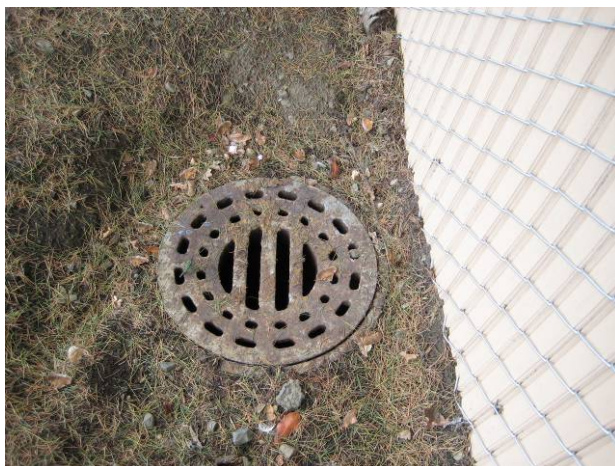
The elevated PCB levels we found in the manhole at the top of the Jorgensen Pipe were consistent with previous measurements at this location and with measurements taken at the KCIA intertie on the opposite side of East Marginal Way. Our sample measured 100 mg/kg, whereas a sample taken in 2005 at the same location had 68 mg/kg. Levels recorded across the street at the King County outfall were 36, 51 and 128 mg/kg dw. During the 2005 sampling effort in the Jorgensen pipe, the recorded level in the manhole at the top of the pipe (68 mg/kg dw) was the lowest level recorded in the pipe. PCB levels further down gradient in the Jorgensen Pipe ranged from 731 to 10,000 mg/kg dw. with the highest level (10,000 mg/kg dw) recorded near the transformer site on Boeing Phase 2 property.

Photo 5. Manhole at top of Jorgensen Pipe along west side of East marginal Way

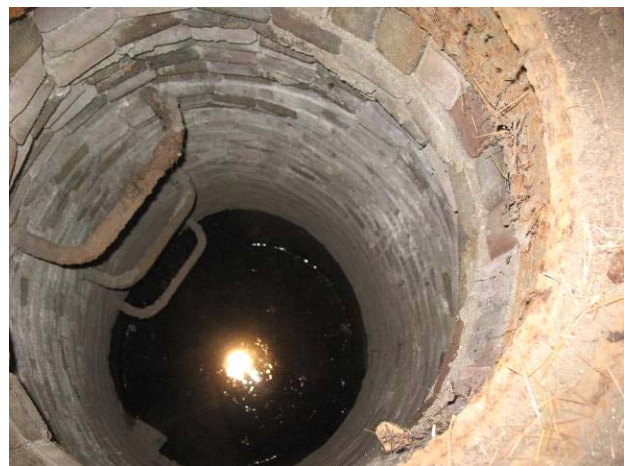
Photo 6. Inside of manhole at top of Jorgensen Forge pipe
